**DRAFT FINAL
Environmental
Baseline
Survey Report**

**St. Louis
Army Ammunition Plant
St. Louis, Missouri**

Date Prepared	:	March 17, 2000
Tetra Tech Project No.	:	G0011-0054KRP02
Prepared by	:	Tetra Tech EM Inc.
Tetra Tech Project Manager	:	Michael Barlage
Telephone No.	:	(312) 856-8700
U.S. Army Aviation and Missile Command Project Manager	:	Valerie Shippers
Telephone No.	:	(256) 876-0211

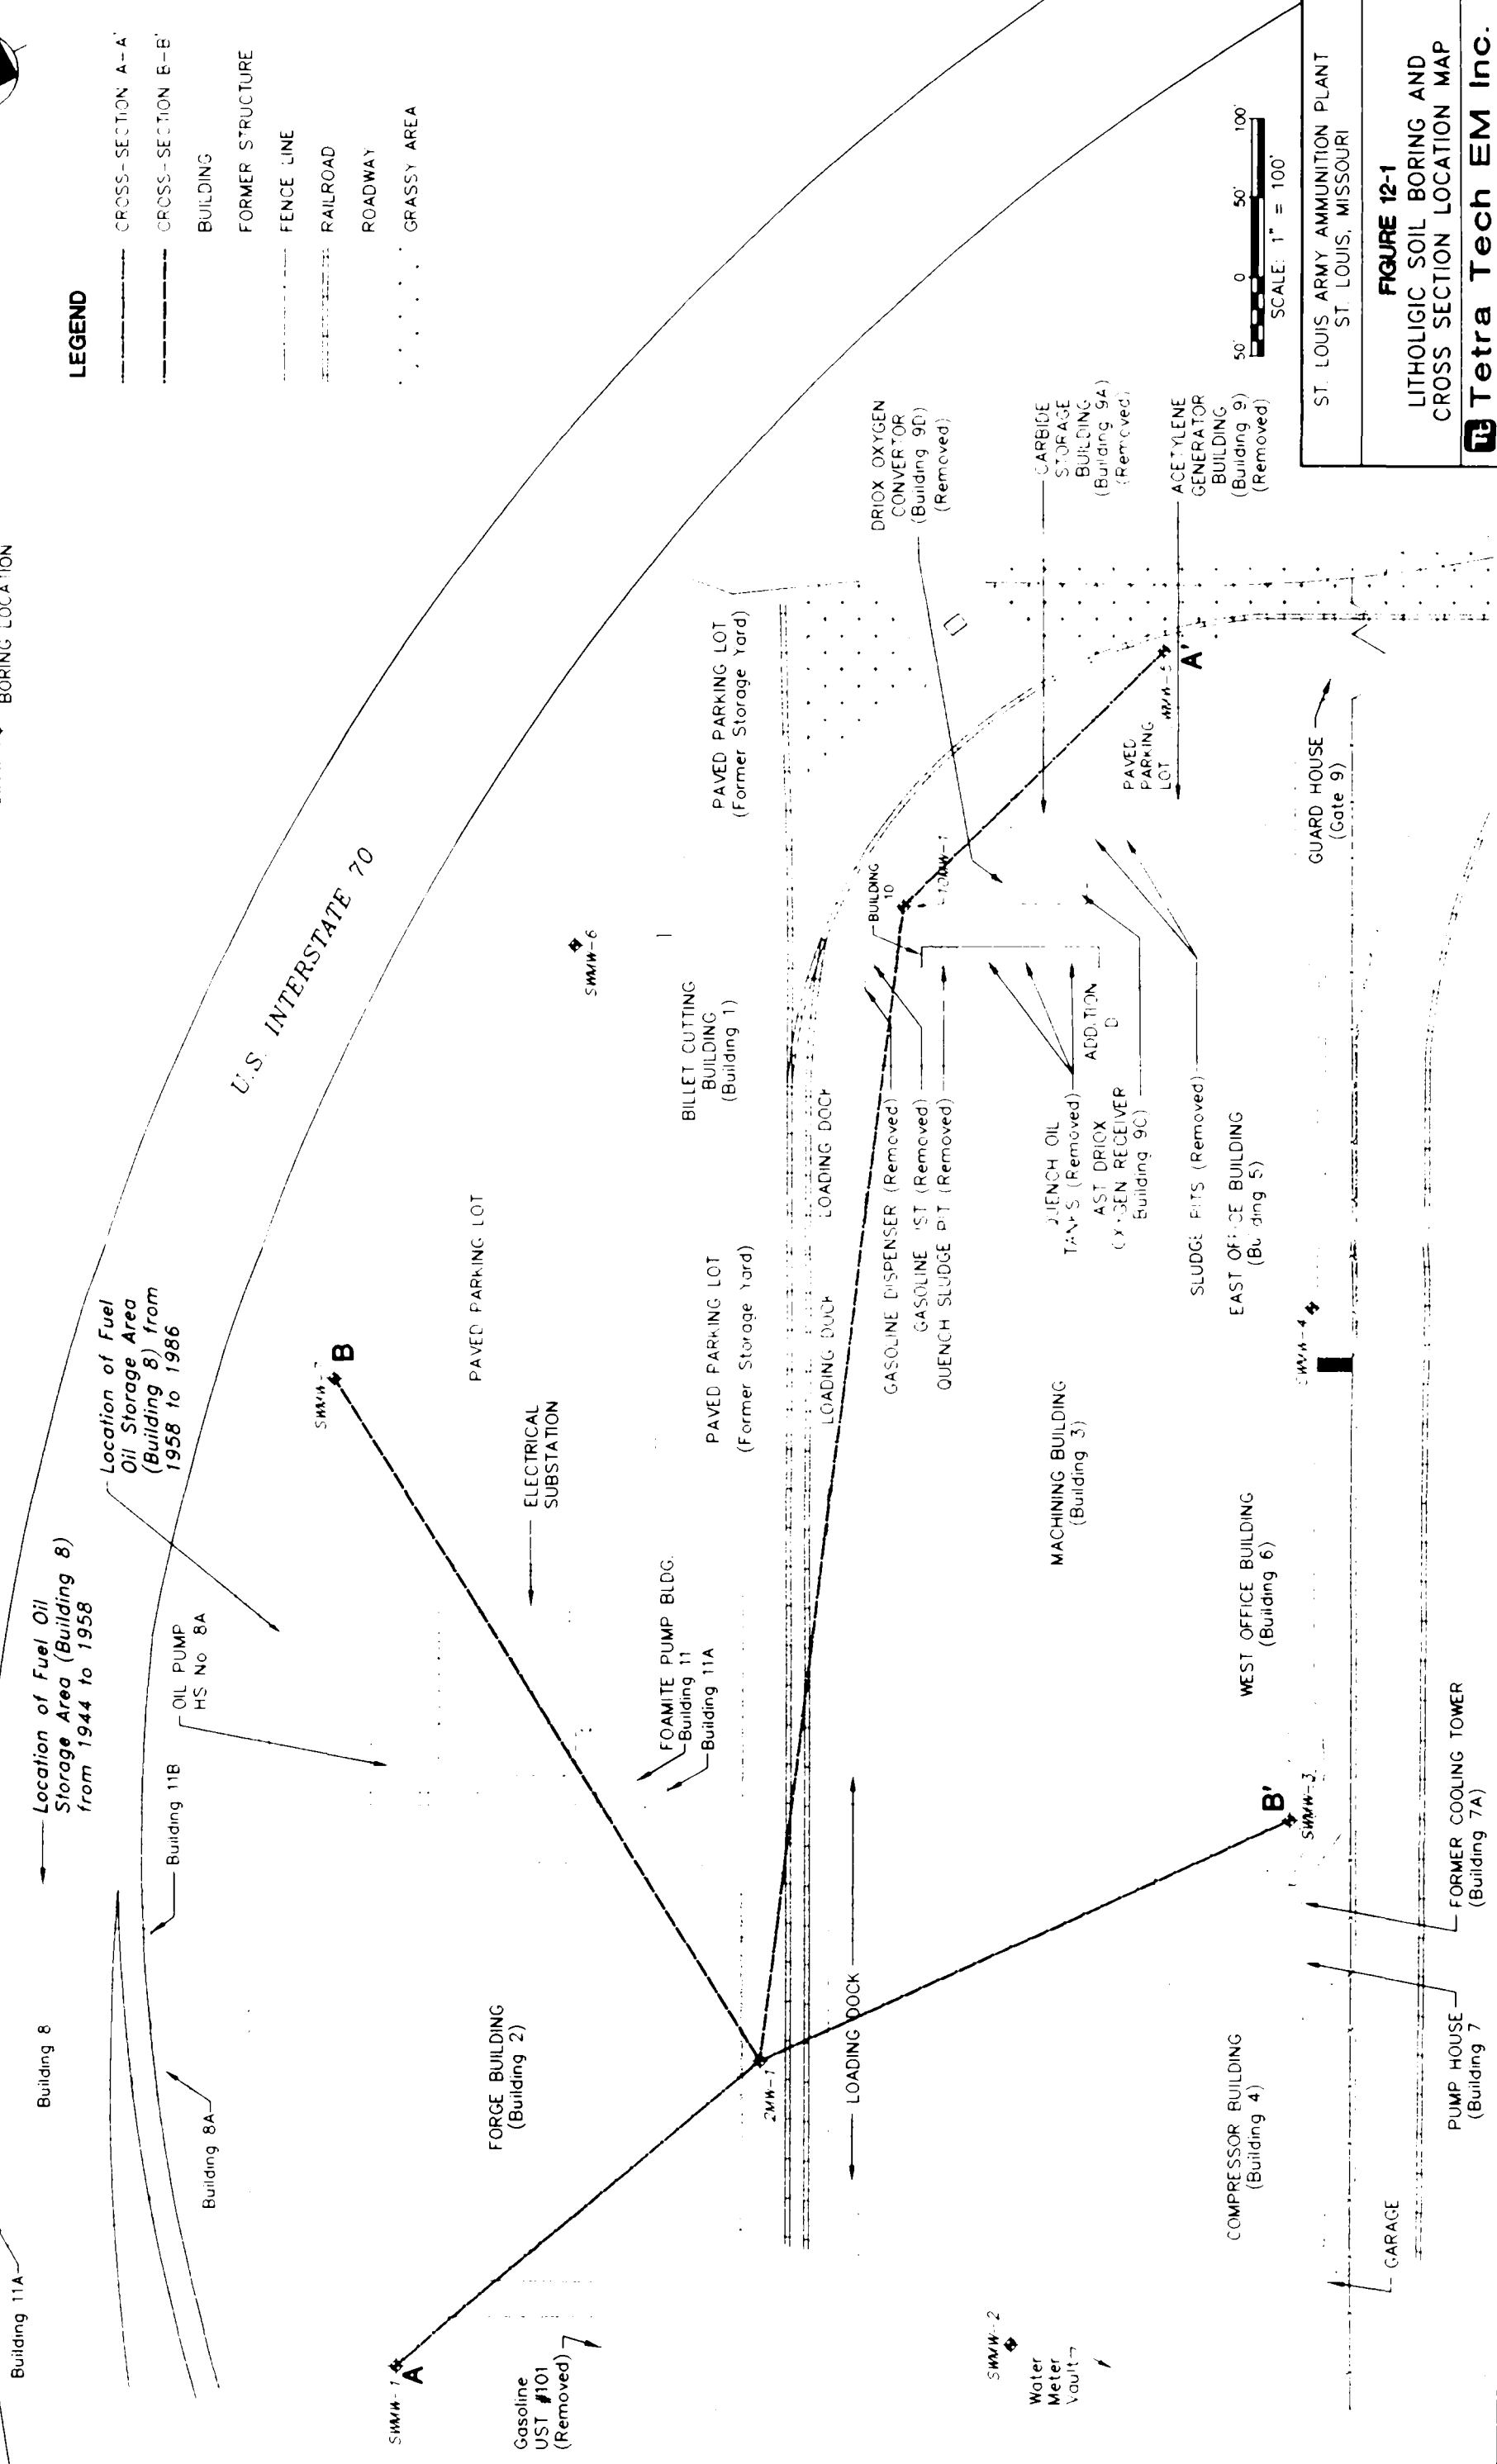
FIGURE 12-1

A total of nine continuously sampled soil borings (SWMW-1 through SWMW-7, 2MW-1, and 10MW-1) were advanced at SLAAP using a truck-mounted drill rig and split-spoon samplers. The soil boring locations are depicted in Figure 12-1. The soil borings were advanced until drill refusal. Upon soil boring completion, the soil borings were converted into monitoring wells. Soil borings advanced at the SLAAP installation indicate that beneath the surficial fill material, the subsurface soils generally consist of layers of clayey silt, chert gravel, silty clay, and weathered shale. The general lithology encountered in each boring is summarized below.

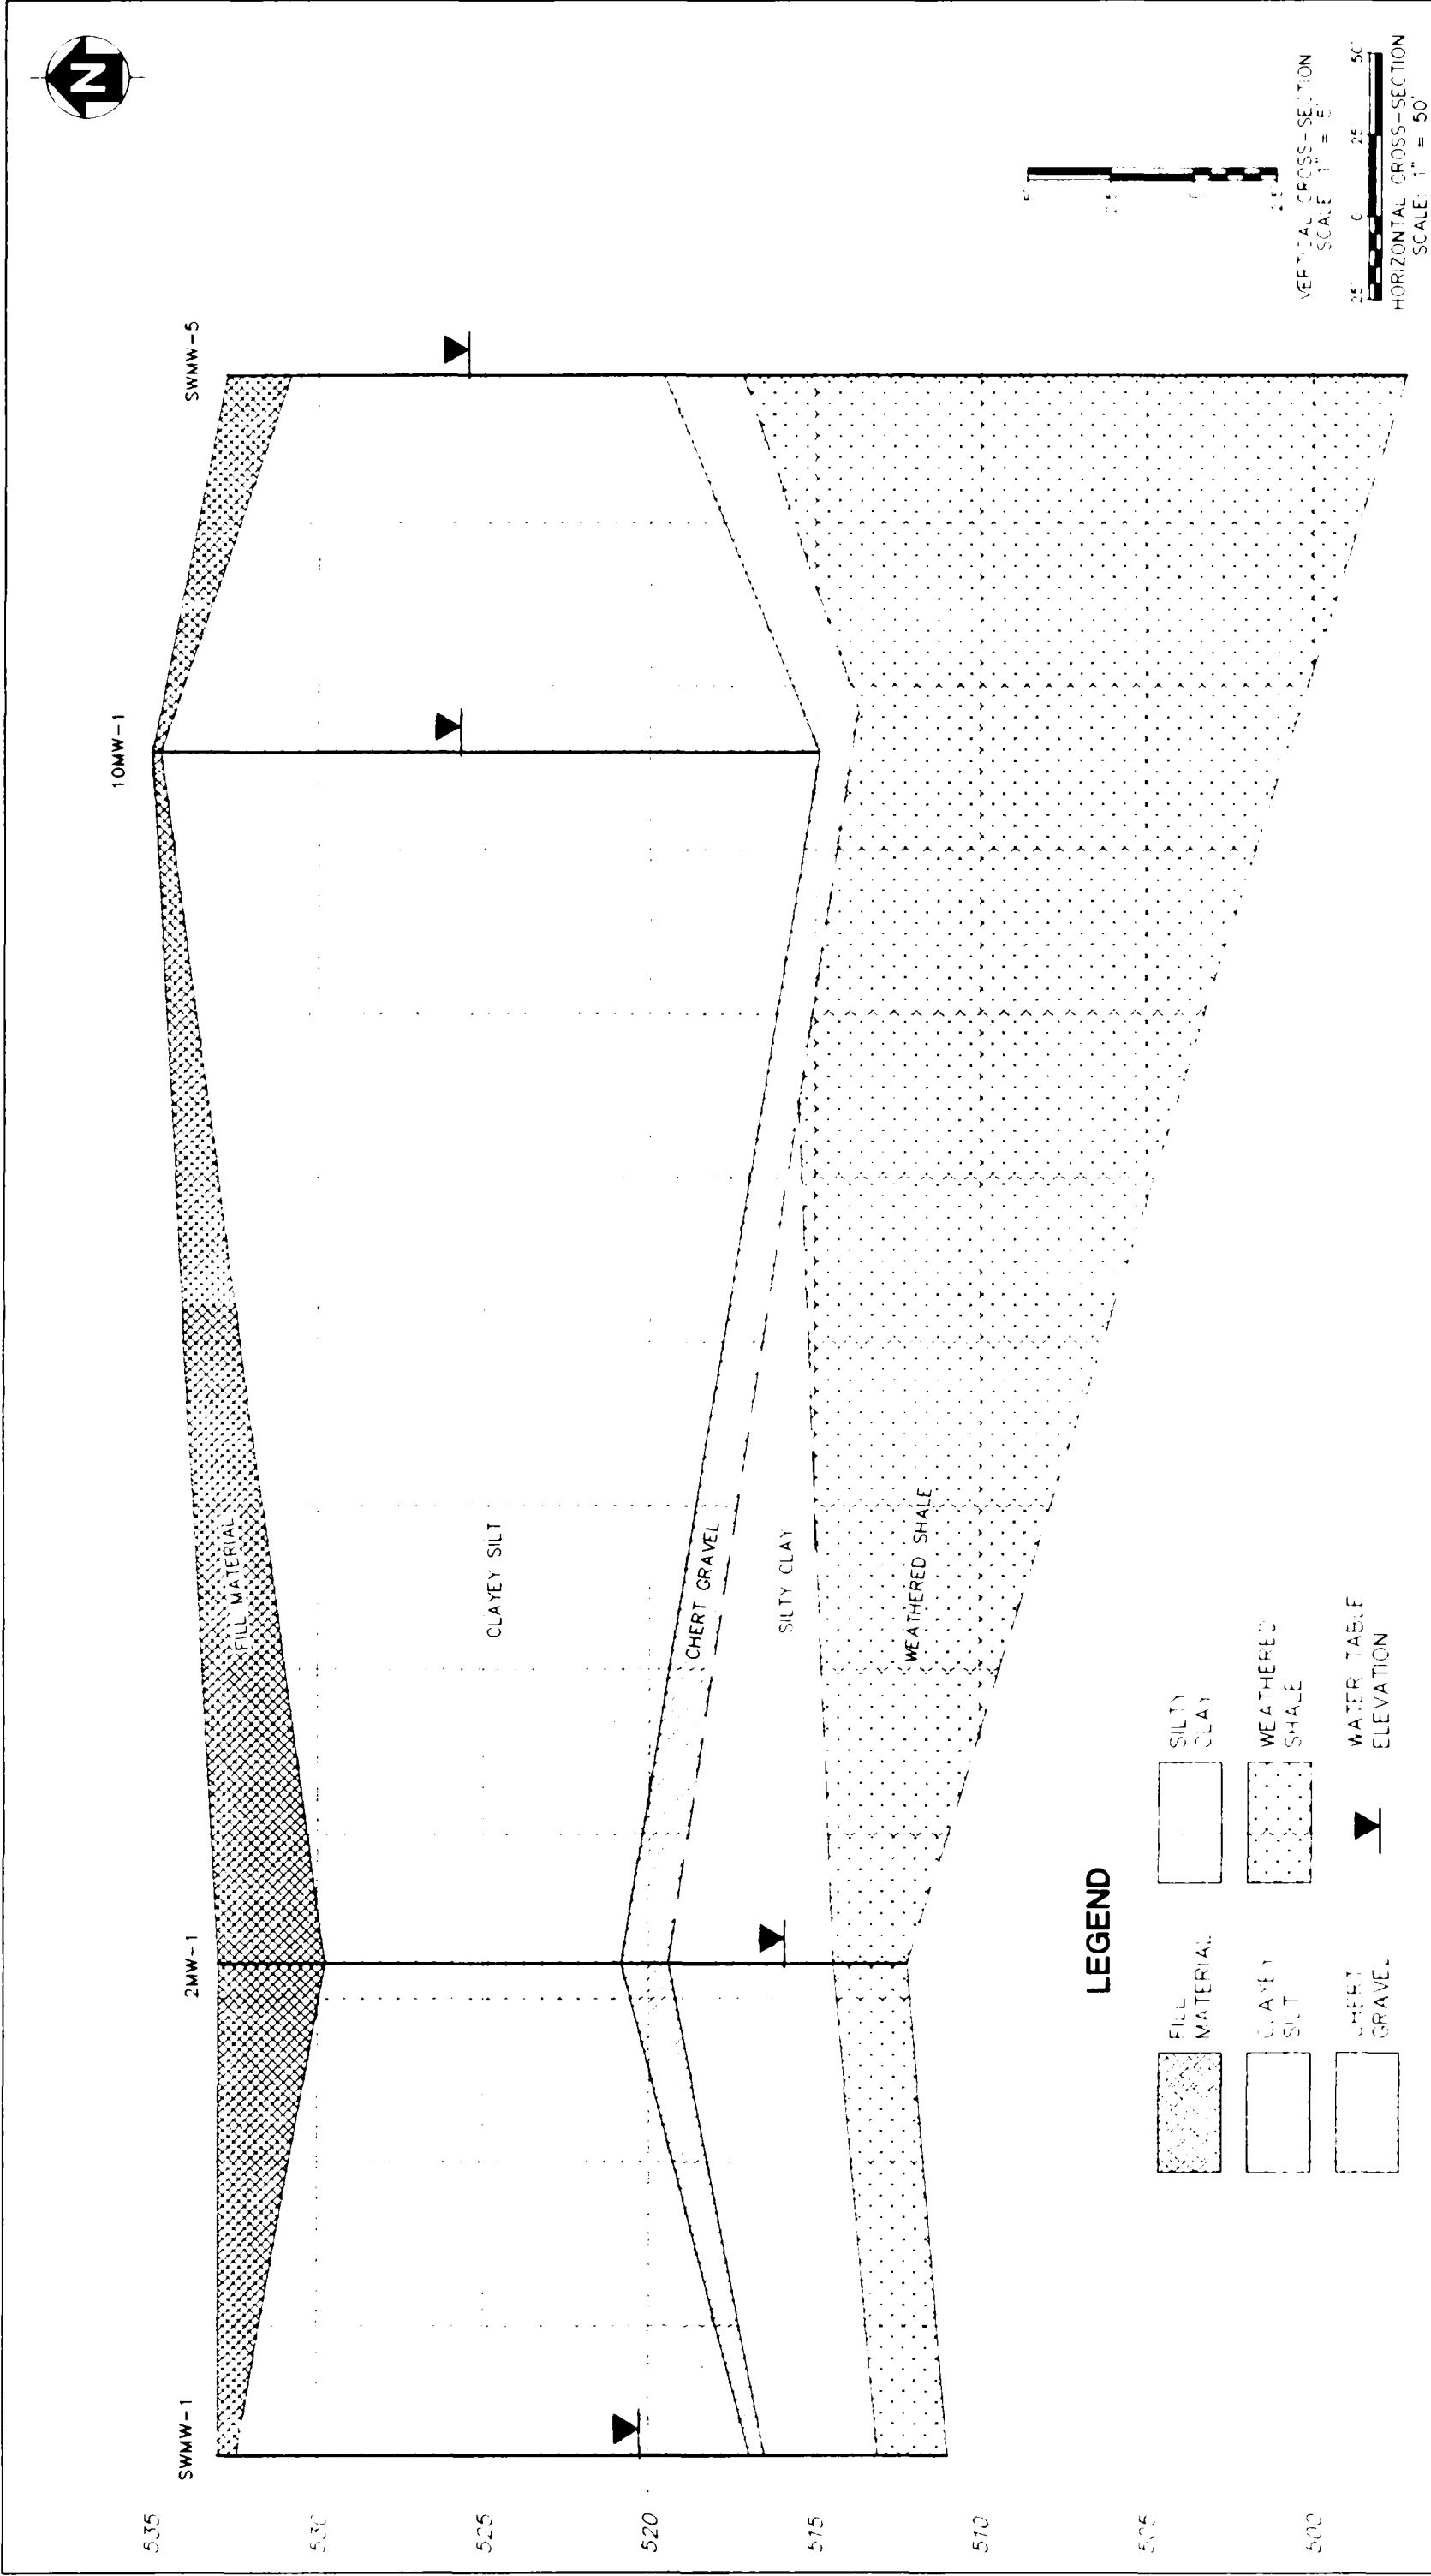
FIGURE 12-2

Boring logs are included in Appendix H. Generalized geologic cross sections are shown in Figures 12-2 and 12-3. The clayey silt and silty clay lithology observed in the soil borings did not appear to be readily transmissive of groundwater. The chert gravel in the chert gravel layer was suspended in a massive clay matrix that does not readily allow groundwater movement and that was dry when encountered. Visual indications of groundwater were identified in siltier seams and in the clayey silt directly overlying the chert gravel layer.

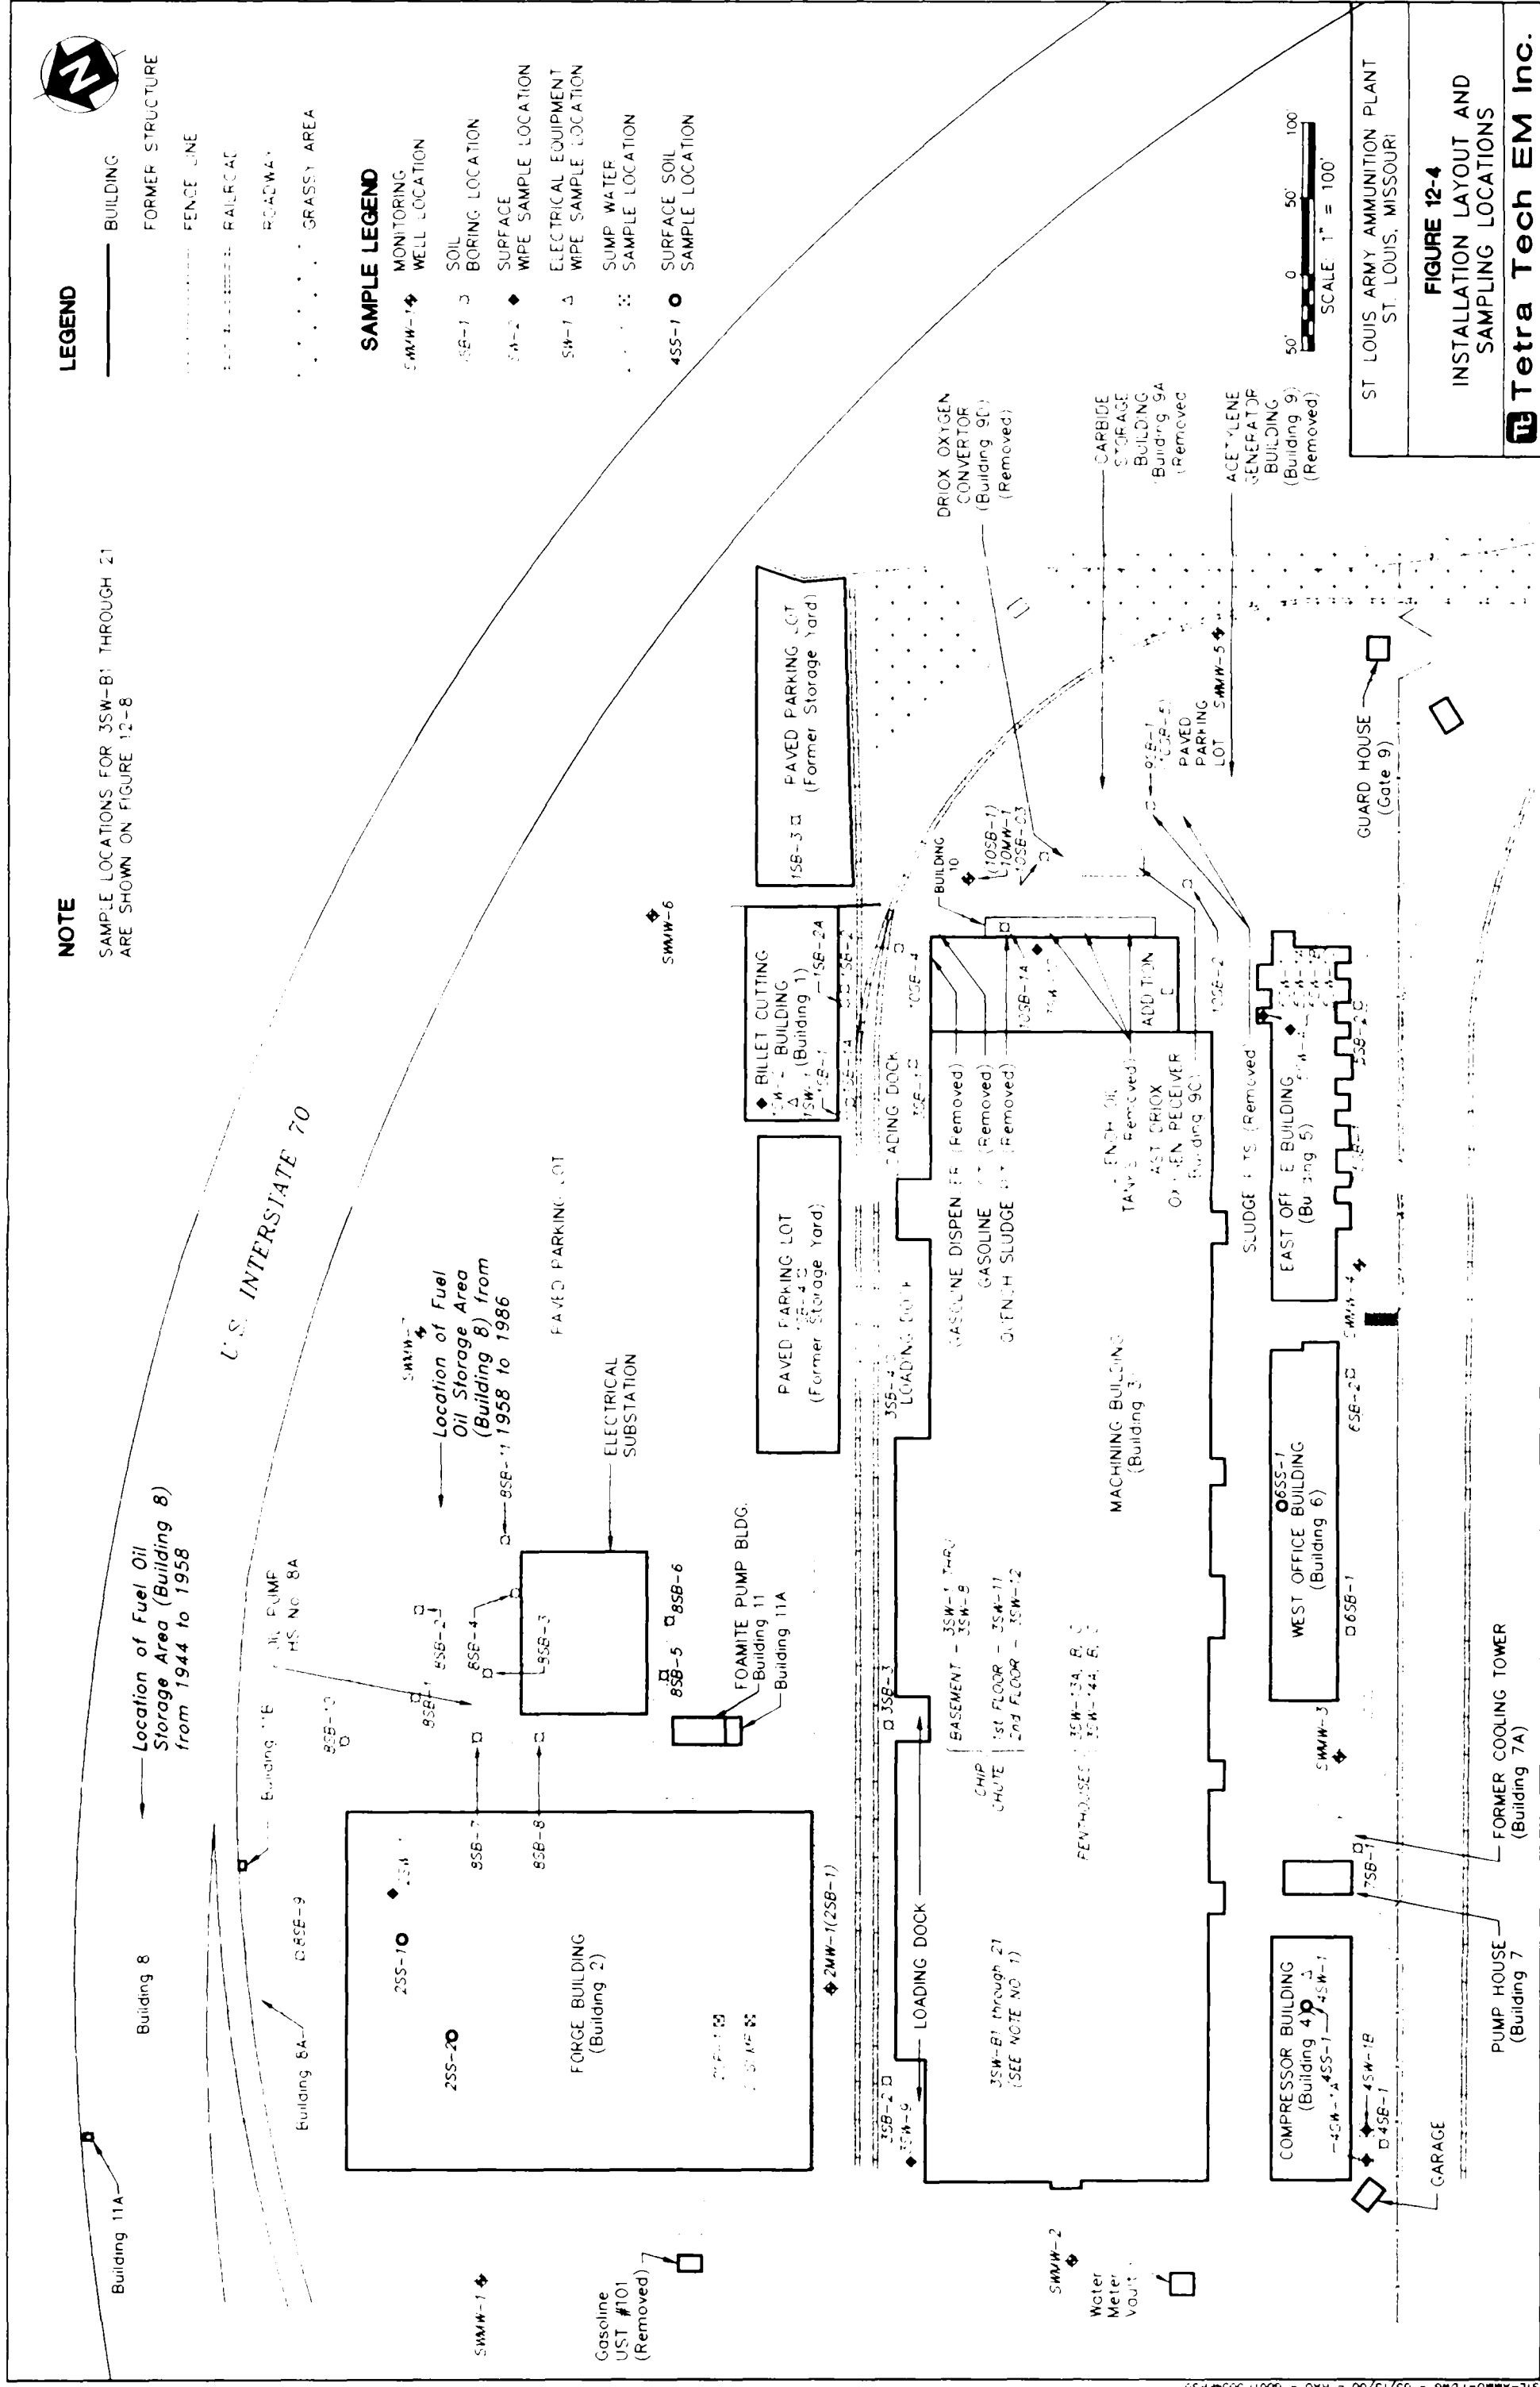
FIGURE 12-4
INSTALLATION LAYOUT
SAMPLING LOCATION

Seven sitewide monitoring wells (SWMW-1 through SWMW-7) were installed along the SLAAP property boundary to collect sitewide groundwater data. Also, two monitoring wells (2MW-1 and 10MW-1) were installed to assess groundwater quality in areas downgradient of possible areas of environmental concern. The monitoring well locations are depicted in Figure 12-4. Groundwater flow and groundwater quality results are discussed below.

Soil borings 1SB-1 through 1SB-4, 1SB-1A, and 1SB-2A were advanced and sampled near Building 1. Additionally, two wipe samples (1SW-1 and 1SW-2) were collected from Building 1. Soil borings 1SB-1 and 1SB-2 were completed during the first phase of field activities. Soil borings 1SB-1A and 1SB-2A were completed within 1 foot of the original 1SB-1 and 1SB-2 during the second phase of field activities. Soil borings 1SB-1 and 1SB-2 were advanced to characterize soil in the vicinity of pits that connect Building 1 to the sewer system. Soil borings 1SB-3 and 1SB-4 were advanced to assess the soil in the former steel billet storage areas. The wipe samples were collected to determine whether the oil stain beneath the electrical equipment and oil stains on the floor of the building contained PCBs. Building 1 sampling locations are depicted in Figure 12-4. Building 1 soil boring and headspace analysis results are summarized below.

One soil boring and one monitoring well were completed and sampled at Building 2. Also, two sump water samples, one wipe sample, and two surface soil samples were collected. The soil boring (2SB-1) and monitoring well (2MW-1) were completed to assess subsurface media near the end of the fuel oil pipeline system. The sump water samples (2SP-1 and 2Sump) were collected to assess the quality of water in sumps present in Building 2; one sump was sampled on two occasions for analysis for different parameters. The wipe sample (2SW-1) was collected to assess the oil stain in the northeast corner of the building near the former location of a rotary furnace. Two surface soil samples (2SS-1 and 2SS-2) were collected to assess soil quality in areas near the former rotary furnaces. Building 2 sampling locations are depicted in Figure 12-4. Building 2 soil boring and headspace analysis results are summarized below.

One soil boring (4SB-1) was completed and sampled at Building 4. Also, three wipe samples and one surface soil sample were collected. Soil boring 4SB-1 was advanced at the former transformer pad location at the southwest corner of the building. The wipe samples were collected to determine the PCB content of oil spilled from electrical equipment and from an oil stove. The surface soil sample was collected from a pit beneath the former air compressor to assess soil quality. Sampling locations are depicted in Figure 12-4. Soil boring results are summarized below.

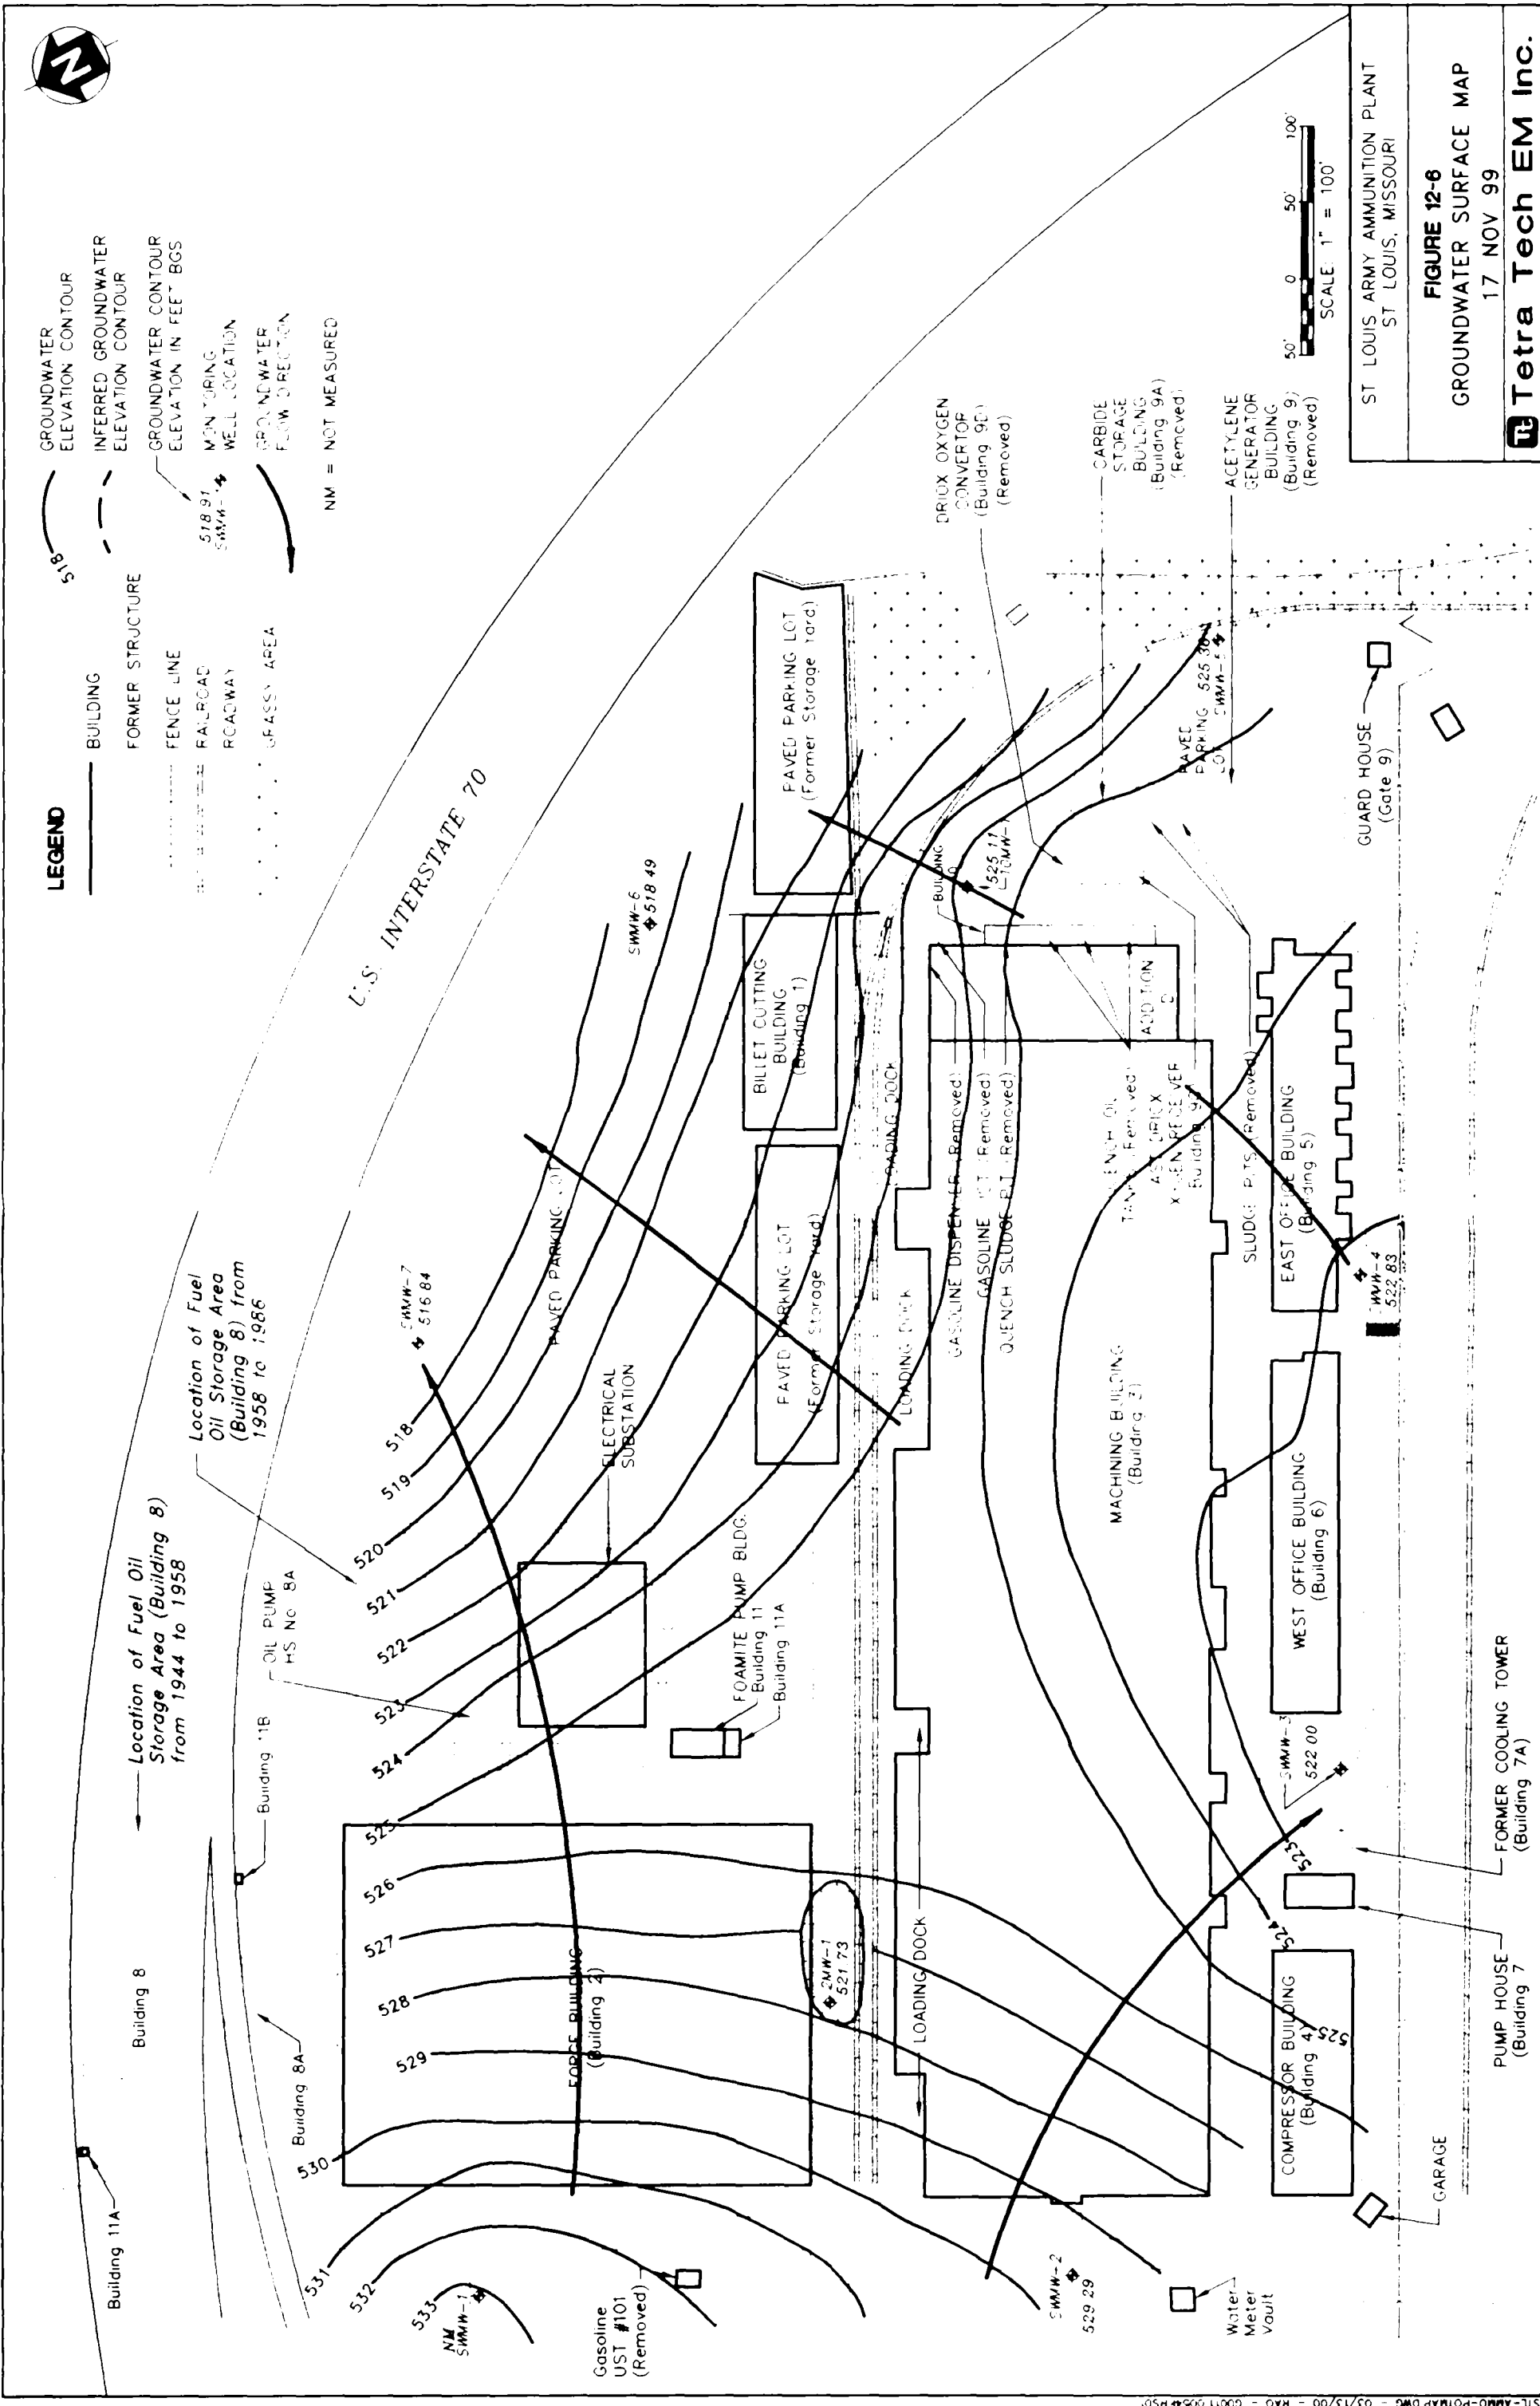
Groundwater flow maps for the 29 Jul, 2 Aug, and 17 Nov data sets are shown in Figures 12-5, 12-6, and 12-7, respectively. The groundwater elevations indicate that groundwater flows onto the SLAAP installation from the west. The groundwater surface then appears to form a "saddle" under Building 3. This saddle results in radial flow of groundwater from the high groundwater elevation under Building 3 to the lower groundwater elevations north, east, and south of Building 3. Because SLAAP is at a higher elevation than I-70 located north and east of the installation and the property located south of the installation, it appears that the groundwater flow is following the regional topography. Groundwater sample collection pumping rates were recorded, and the groundwater flow through the screened saturated units underlying SLAAP is too slow to maintain a constant flow of 0.5 liter per minute. Therefore, it appears that these saturated units cannot be used as sources of potable groundwater.

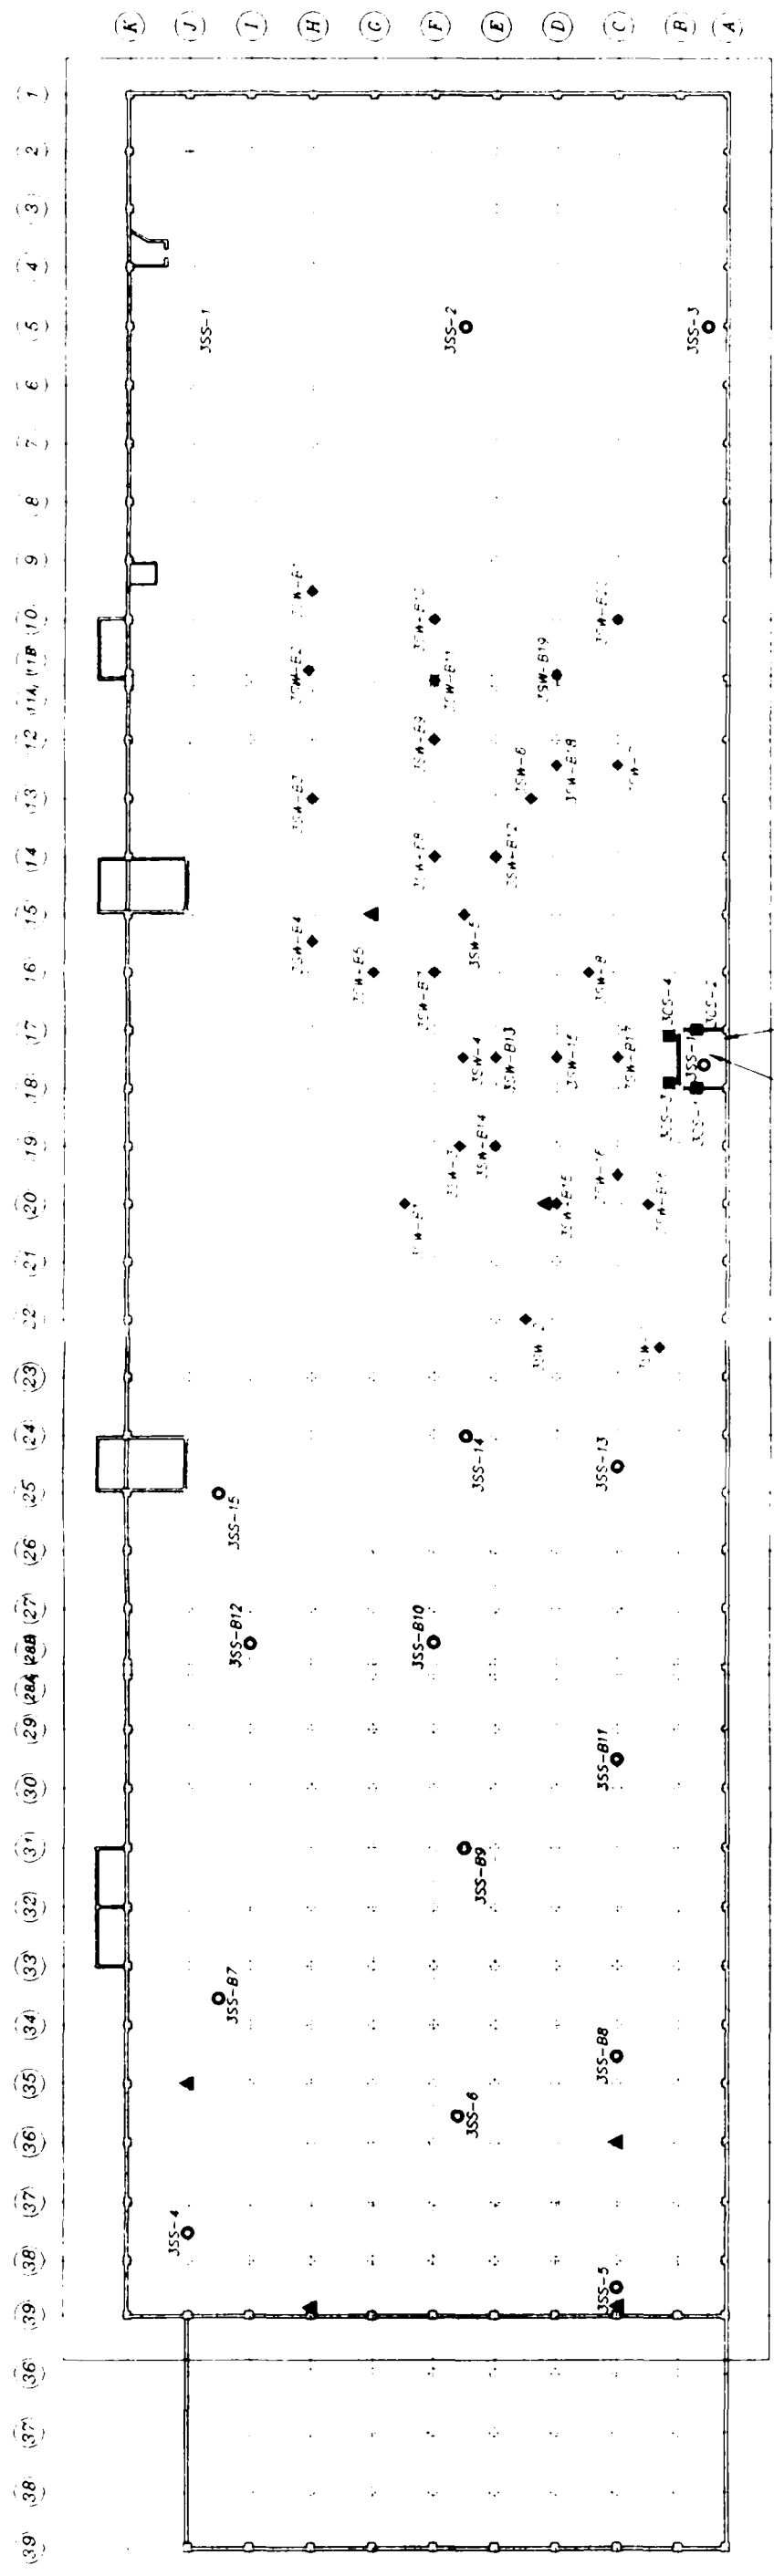
The soil borings were completed to assess soils at the remote quench oil fill and at the loading docks. The wipe samples were collected to assess possible PCB contamination in the basement, on the first and second floors near the chip chute, and in the elevator penthouse. Concrete core samples were collected to assess possible PCB contamination in the walls of the former chip chute and in structural components of the basement. The air samples were collected to assess ambient air quality in the basement. The floor drain samples were collected to assess the quality of water in a floor drain in the basement and in the floor drain that serviced the solvent room. The surface soil samples were collected to assess soil quality throughout the basement. Building 3 outdoor sampling locations are shown in Figure 12-4; Building 3 basement sampling locations are depicted in Figure 12-8. Building 3 soil boring and headspace analysis results are summarized below.
